RE: Central Sands Dairy, Tn. of Armenia, Juneau Co., WI, WPDES #WI-0063533-02-0 – Comments  
Regarding Environmental Conditions

On behalf of Nicholas Karris of Karris Family Farms, I have reviewed the hydrogeological conditions, design and operations at the Central Sands Dairy (CSD) facility and am providing the following observations, conclusions and recommendations:

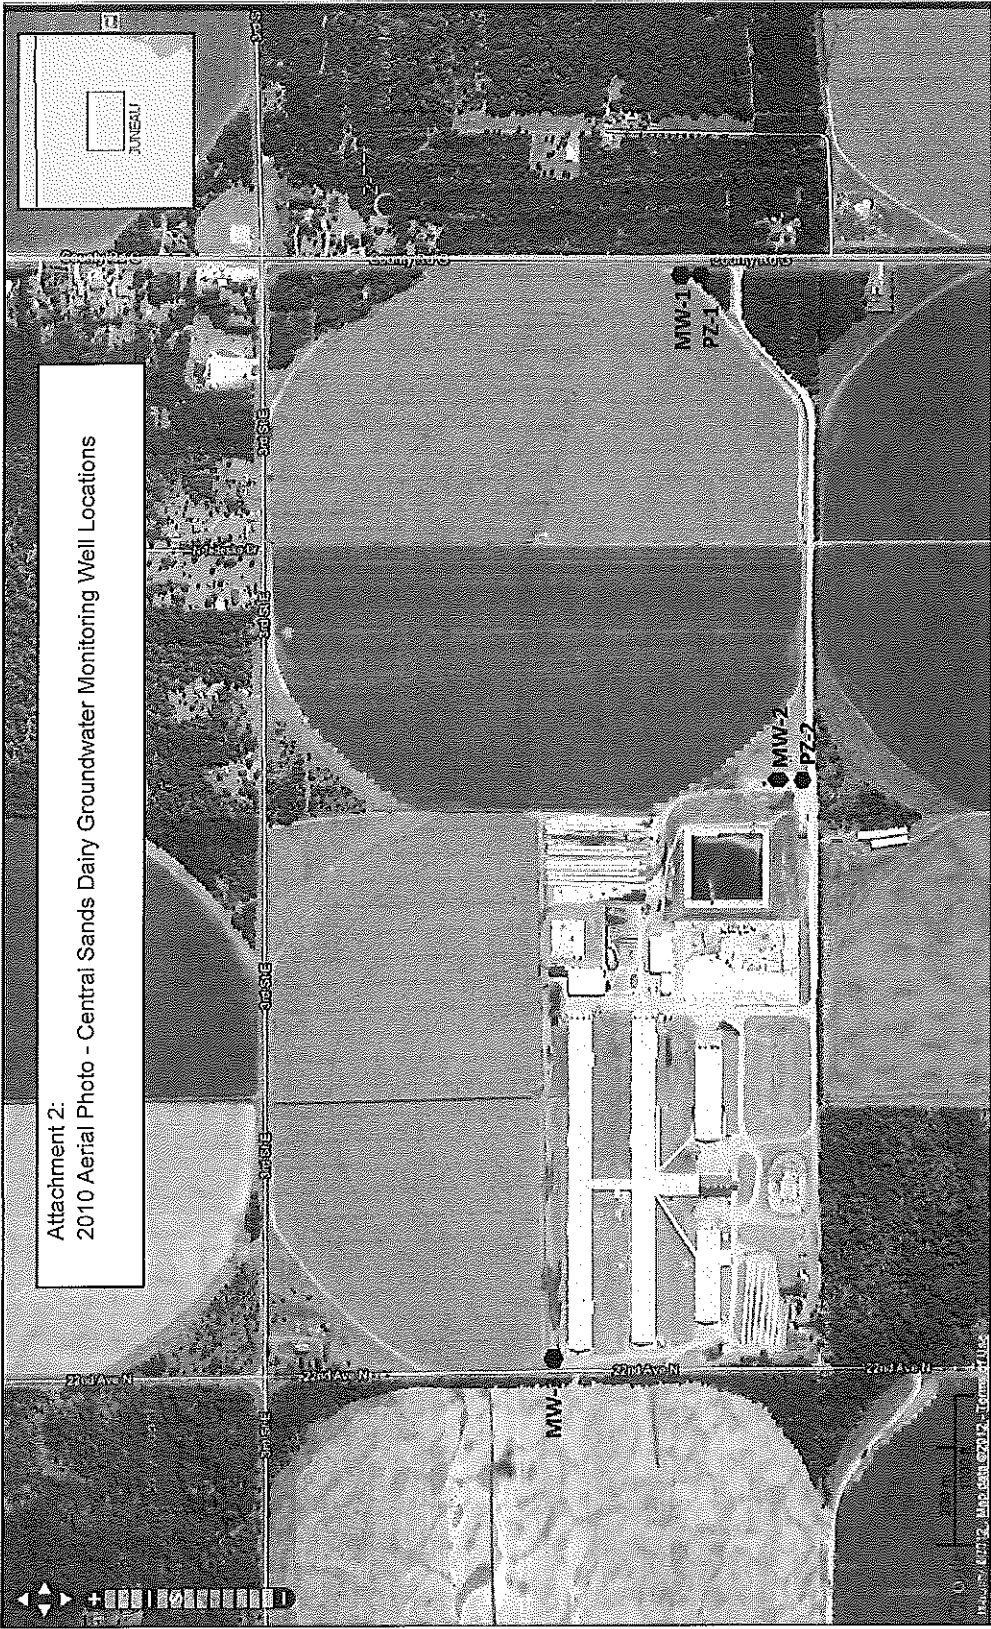
Attachment 2:  
2010 Aerial Photo - Central Sands Dairy Groundwater Monitoring Well Locations

Copies of groundwater sampling results from the five monitoring wells which were placed at three locations were provided by Ken Winters, Town of Armenia Zoning Commission (see Attachment 11, "Table 1"). Approximate locations of the wells are noted on the 2010 Aerial – Central Sands Dairy Groundwater Monitoring Locations" (Attachment 2). This information provided conforms to the well construction data contained in the logs referenced above and includes well screen depths for: MW-2 (15 to 25 feet), PZ-2 (35 to 40 feet), and MW-3 (14 to 24 feet). NO<sub>3</sub>/NO<sub>2</sub> and NH<sub>3</sub>/NH<sub>4</sub> analyses were reported once for each well for 2008, 2009, 2010, and 2011. Since the wells have been sampled in either January or February for each of those years it is expected that sampling results from 2012 may also be available.

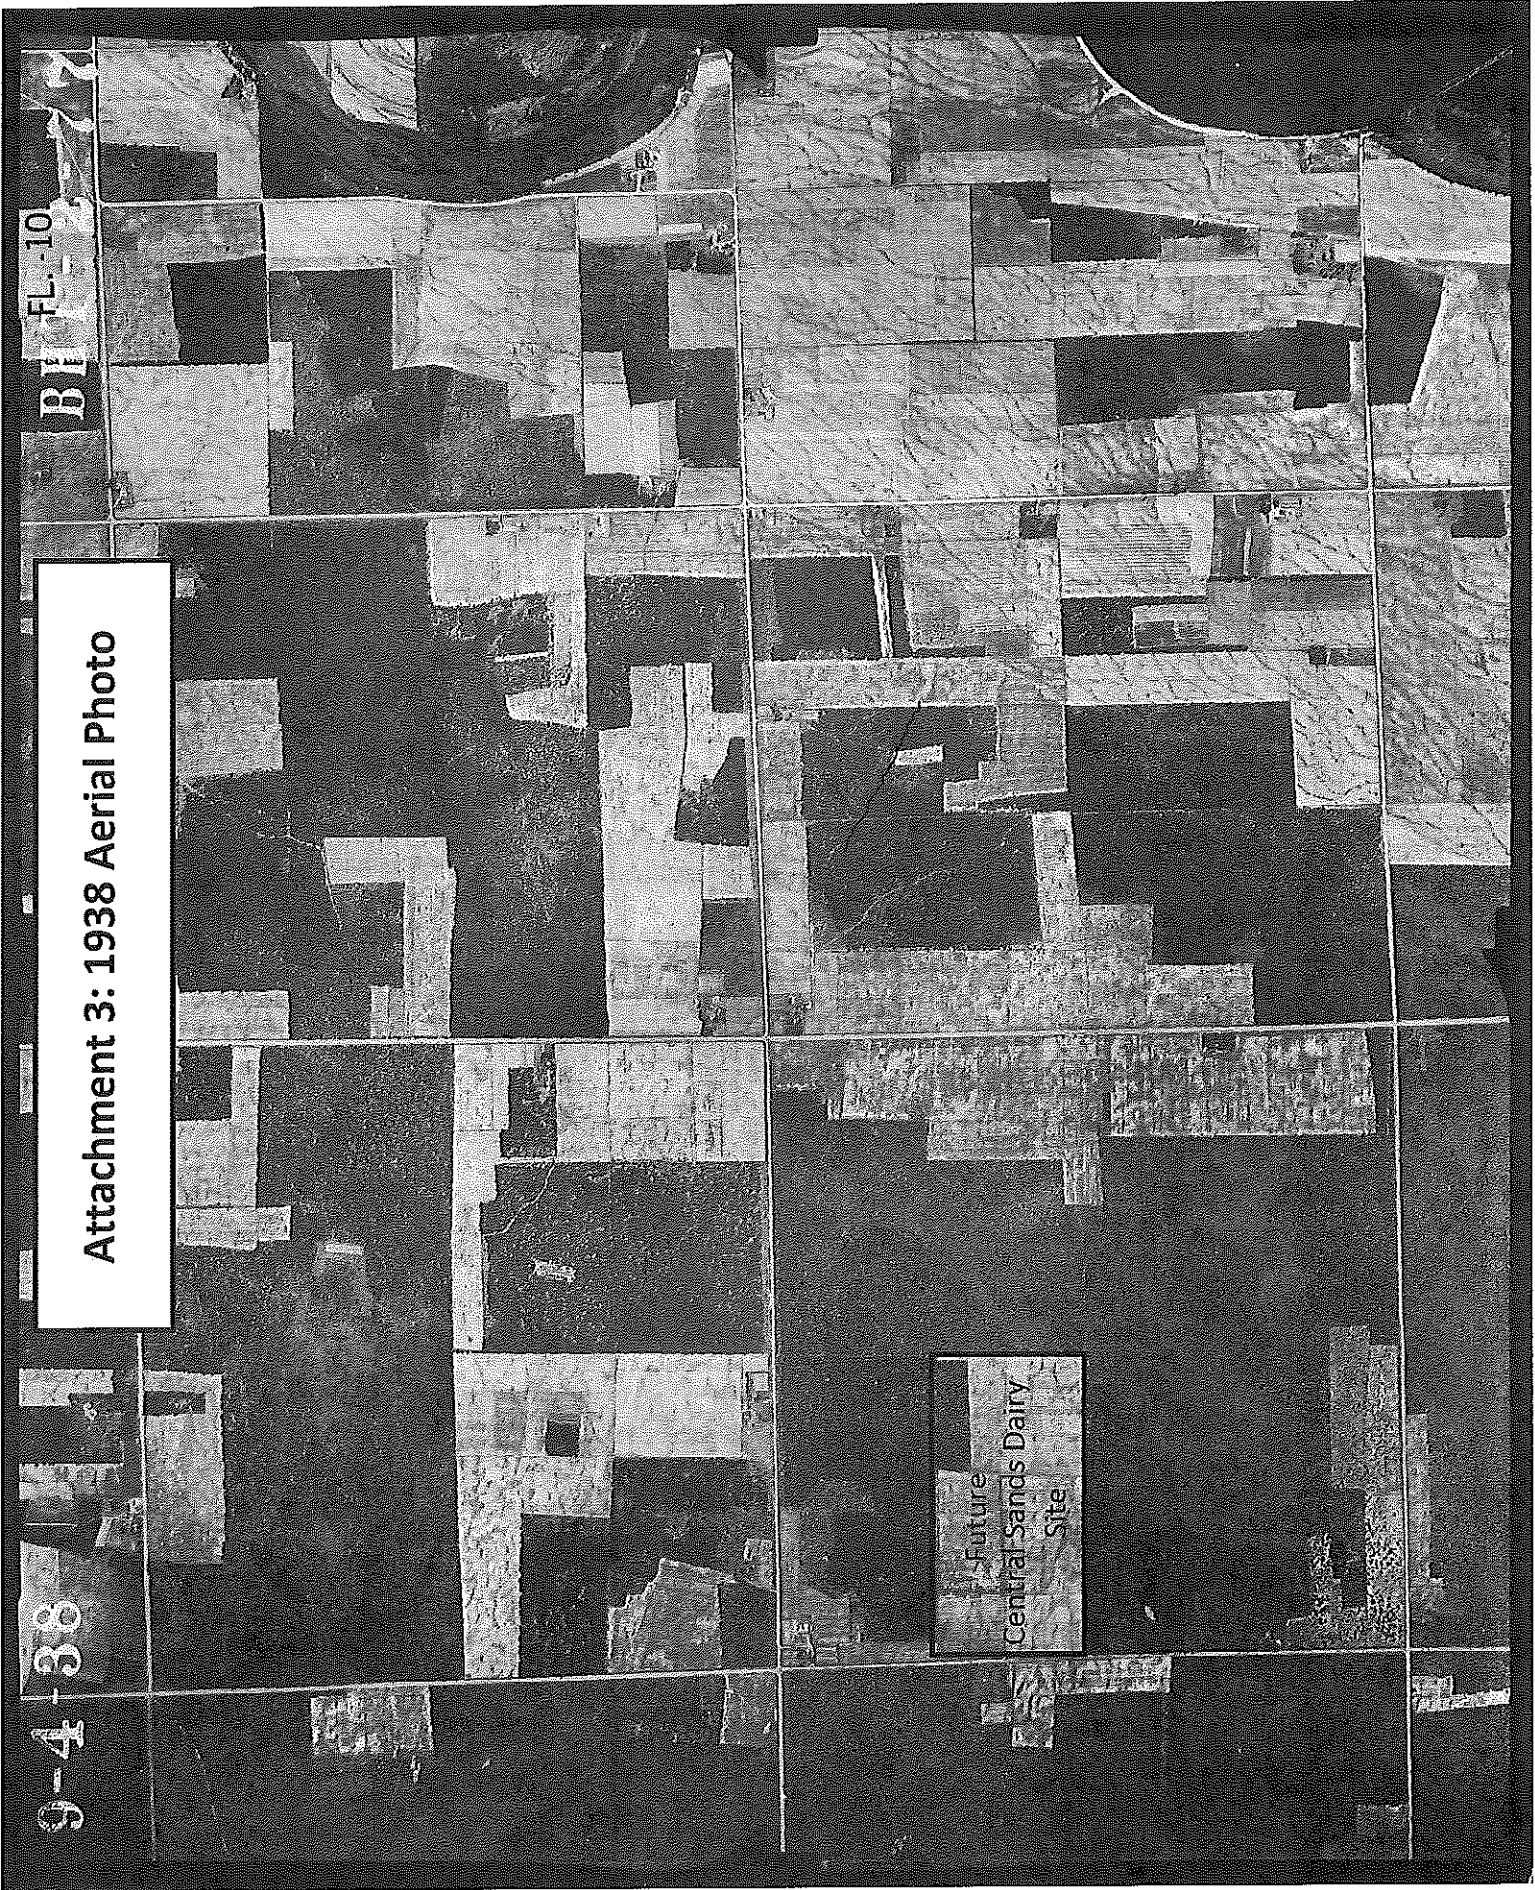
Attachment 3: 1938 Aerial Photo

The 1938 aerial photo (Attachment 3) shows the future CSD site to be agricultural fields with lands to the west forested. The lands to the east transition to increased agriculture use. The 2005 aerial photo

Future  
Central Sands Dairy  
Site

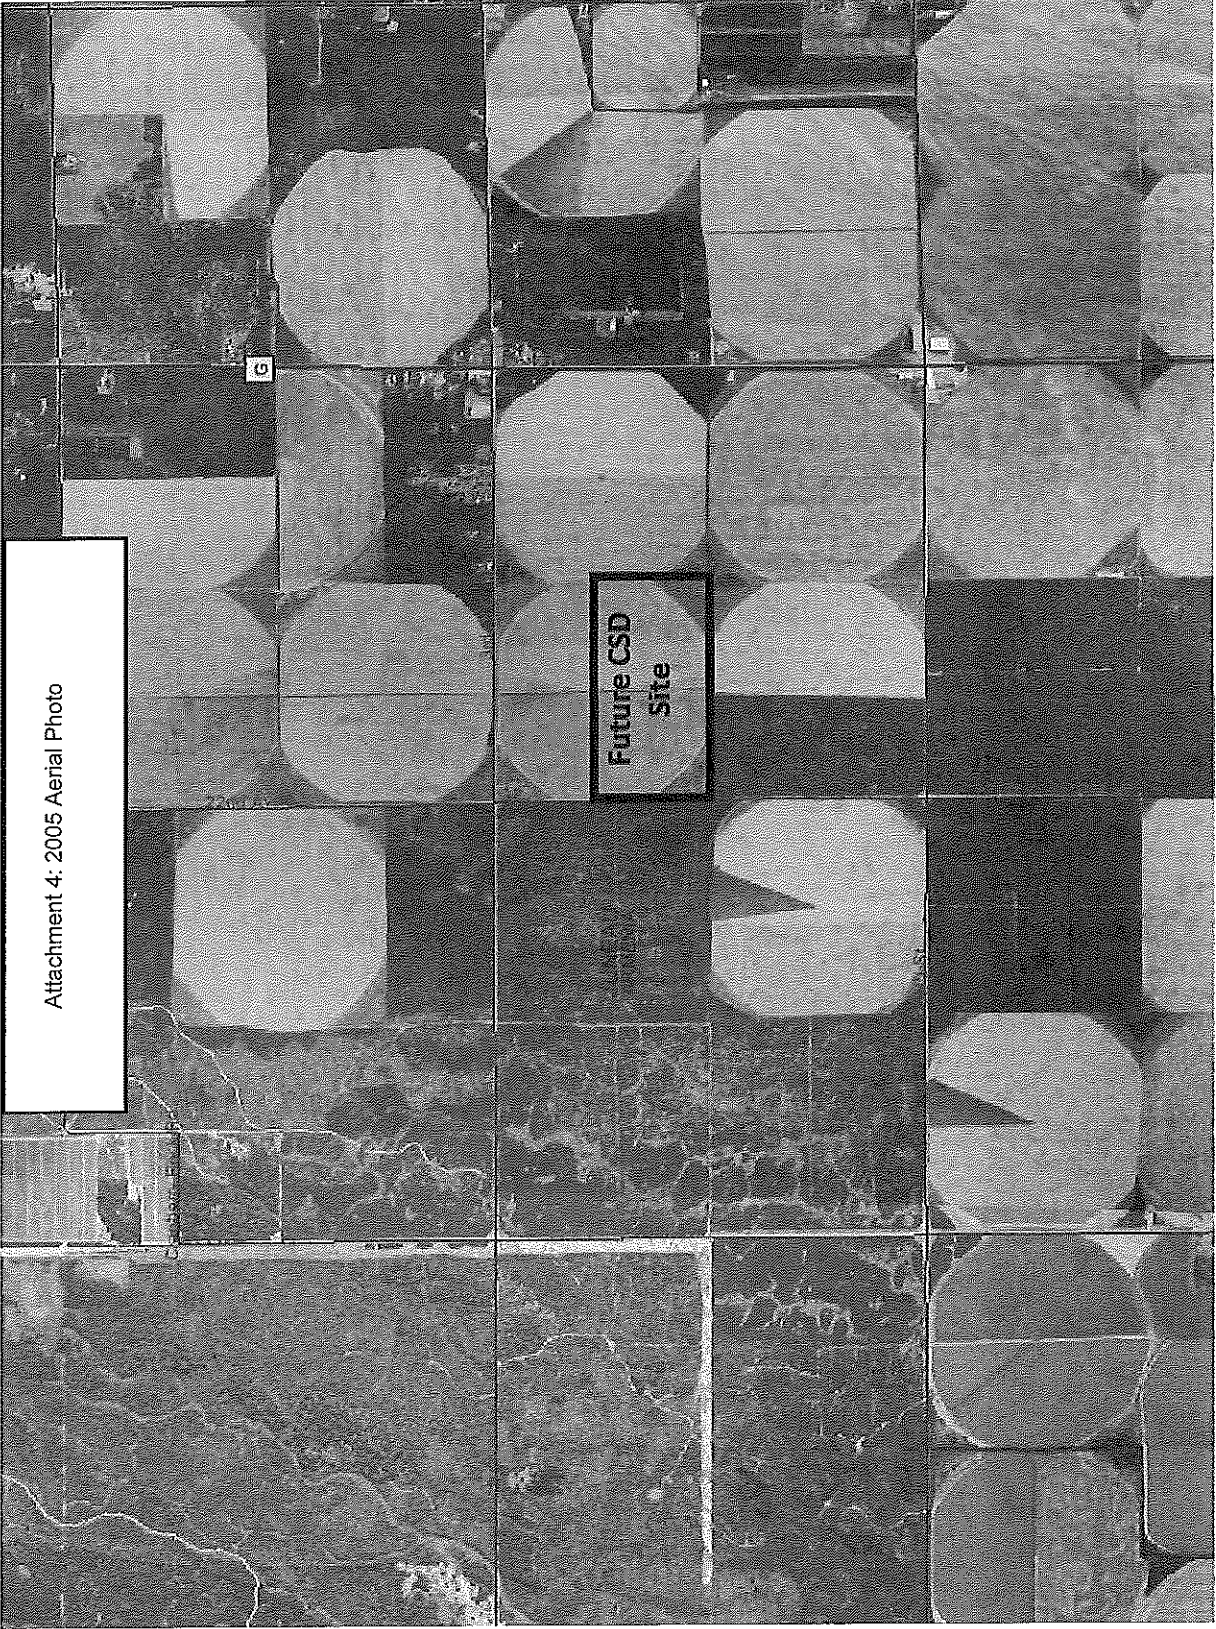
Attachment 4: 2005 Aerial Photo

(Attachment 4) shows the future CSD site to be irrigated agriculture with forested lands to the west. The 2008 aerial photo (Attachment 5) shows the CSD has been constructed and the lands to the west in forest. The 2010 aerial photo (Attachment 6) shows the extent of irrigated area in the CSD area and documents the conversion of 160 acres of forested land to the west of the CSD site (NE ¼ of Sec. 11) and also the 320 acres to its west (W1/2 of Sec. 11) to irrigated agriculture.
